ENVIRONMENTAL INCORPORATED

**Asbestos and Lead-Based Paint Survey Report
Cañon Elementary School
34630 School Loop Rd
Black Canyon City, AZ 85324
AEI 2093**

December 1, 2020

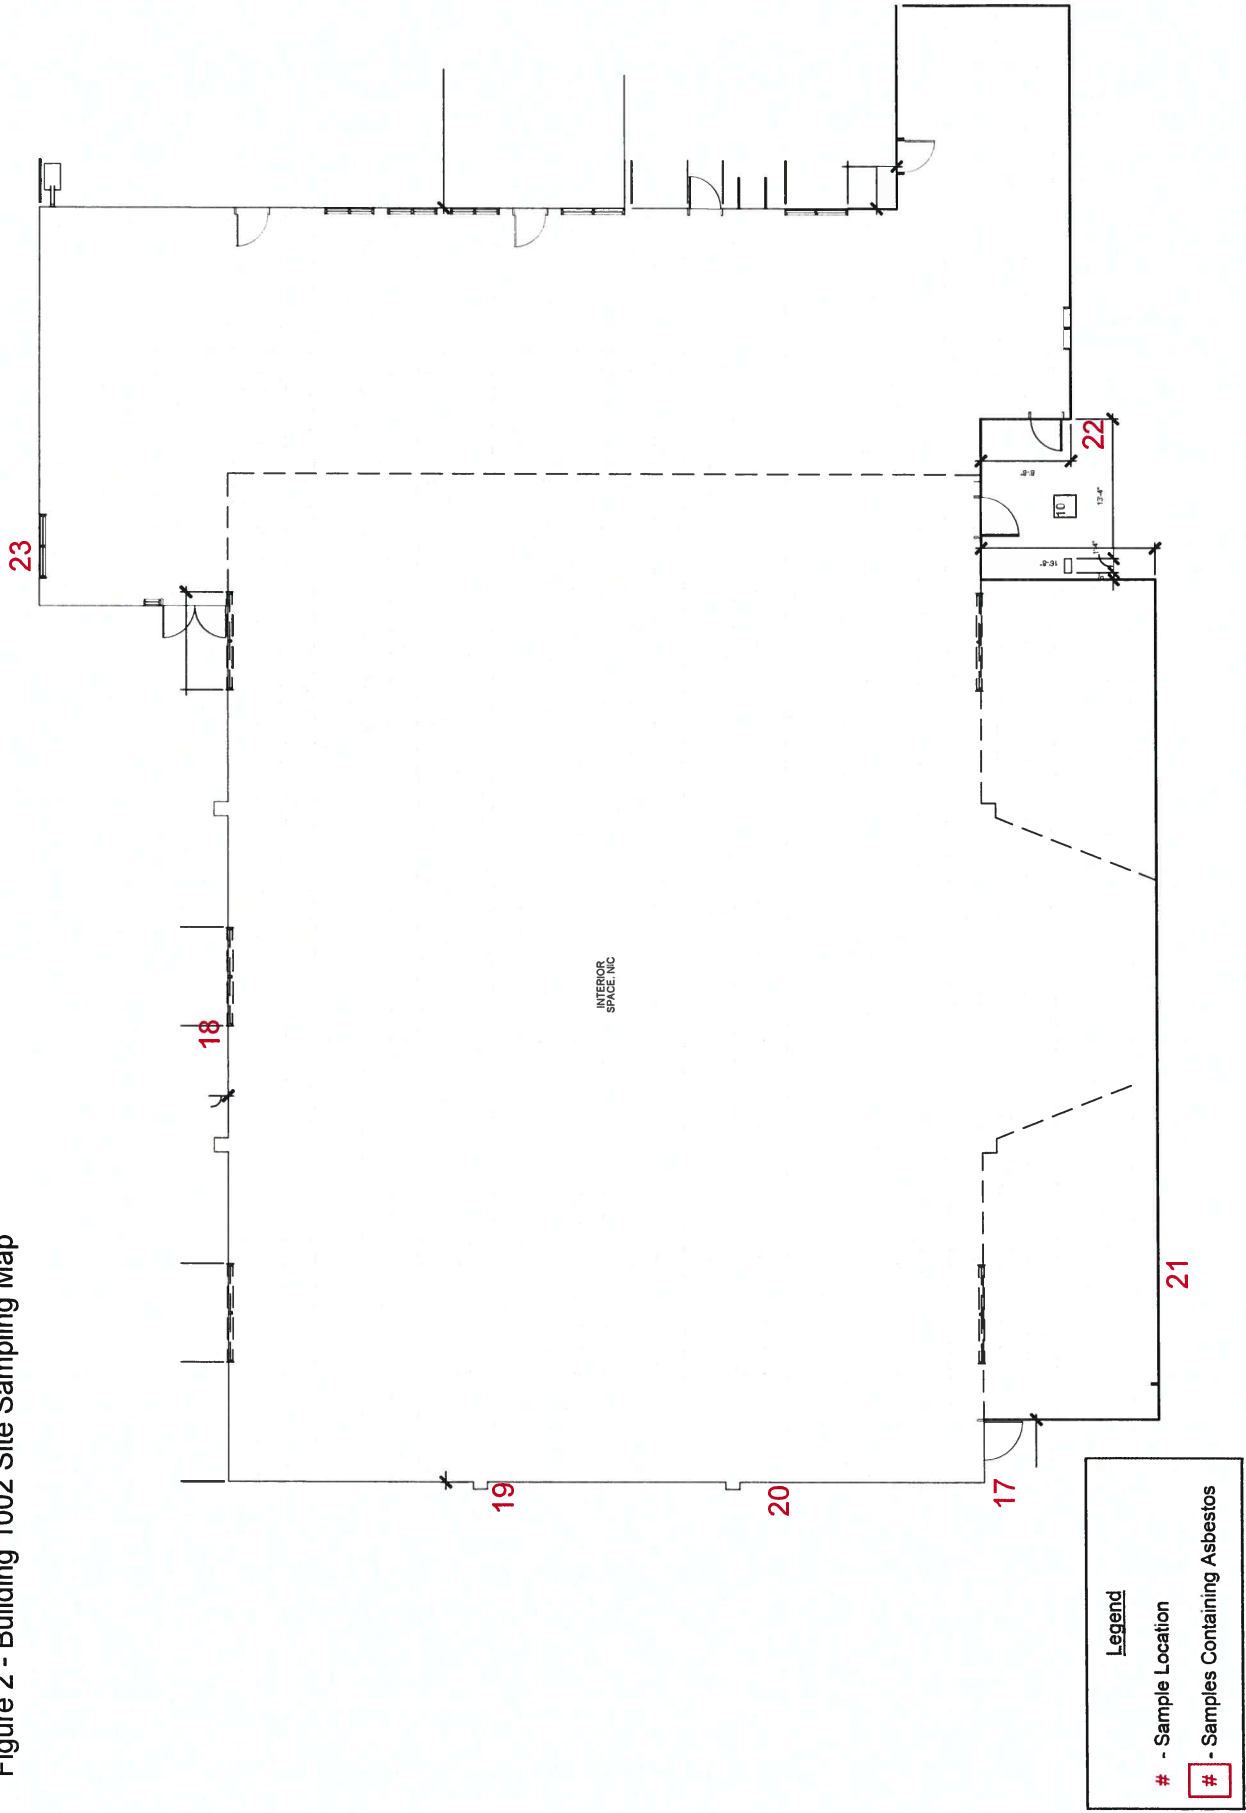
Figure 2 - Building 1002 Site Sampling Map

Asbestos-containing materials that were identified include: **Roof Penetration Sealants.**

Approximately 100 square feet of asbestos-containing roof penetration sealants were identified in Building 1002, at both roof levels. The material is presumed to be present on all roof penetrations within the renovation areas of the roofing system. The material is brown and black in color. The material is also found on skylight flashings and roof repairs. The materials are categorized as Category II asbestos-containing material, in good condition, under the U.S. EPA NESHAP regulation.

Building 1002- Asbestos containing roof penetration sealant is found on both levels of the roof system. Asbestos abatement is needed to remove the existing penetration sealants. This sealant can be found on all penetrations, including skylights.
