ENVIRONMENTAL INCORPORATED

**Asbestos and Lead-Based Paint Survey Report
Cañon Elementary School
34630 School Loop Rd
Black Canyon City, AZ 85324
AEI 2093**

December 1, 2020

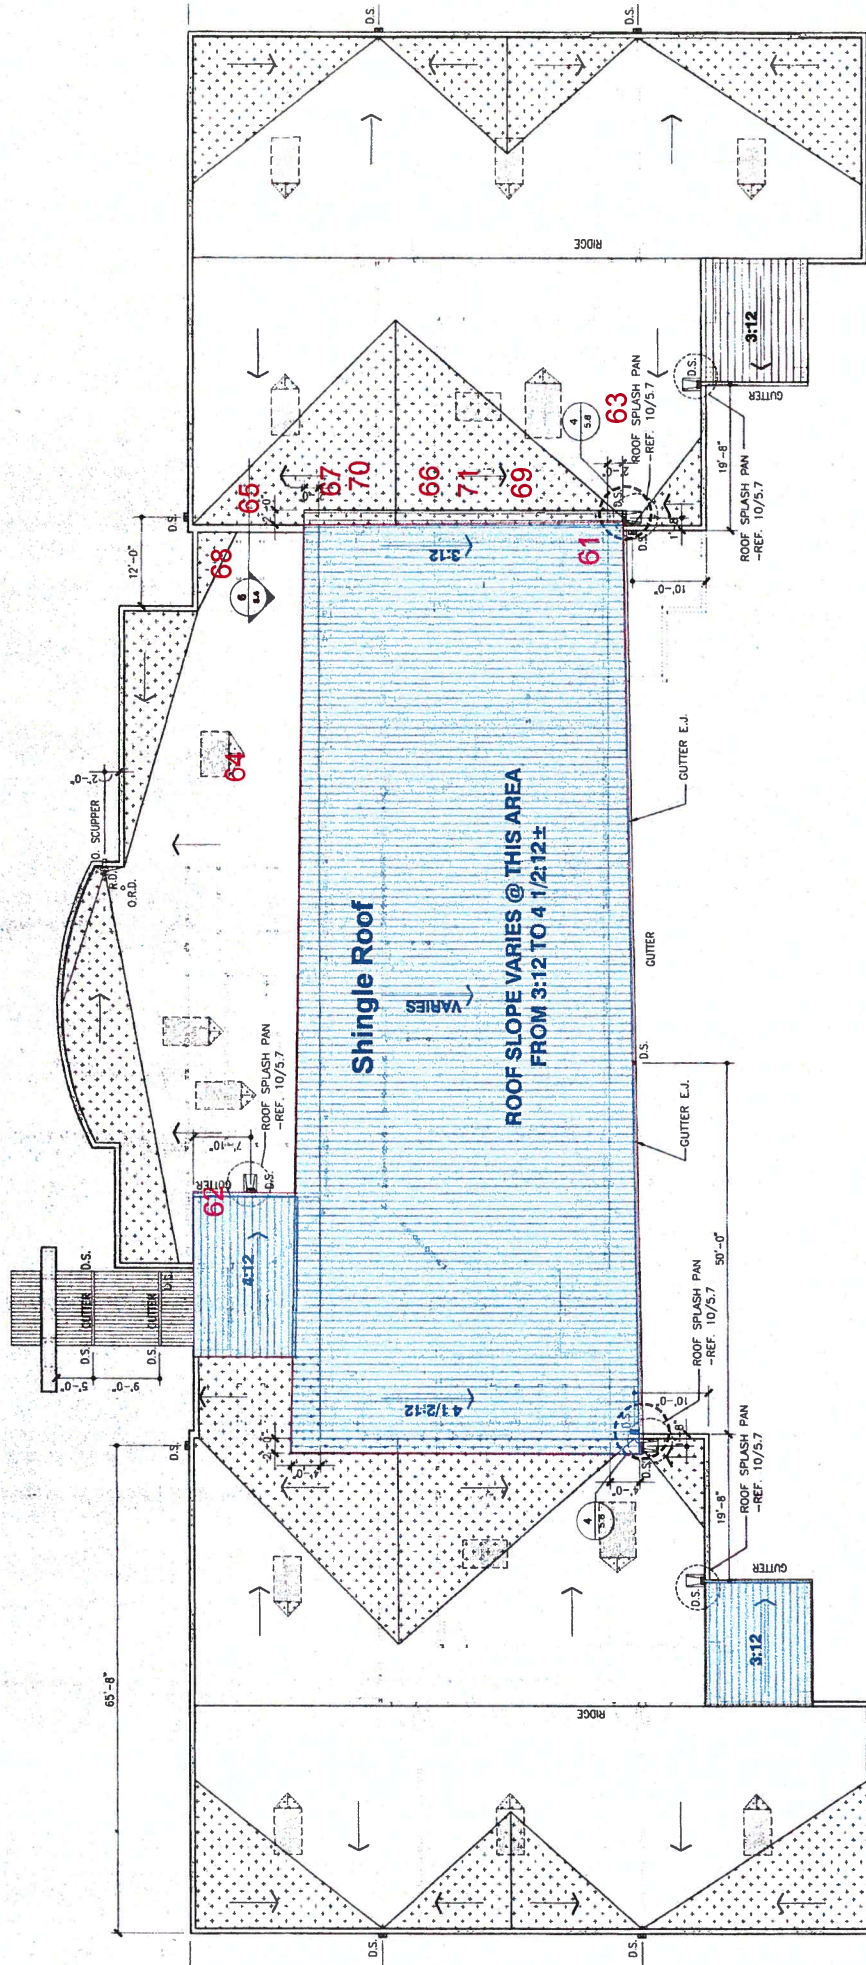
Approximately 100 square feet of asbestos-containing roof penetration sealants were identified in Building 1002, at both roof levels. The material is presumed to be present on all roof penetrations within the renovation areas of the roofing system. The material is brown and black in color. The material is also found on skylight flashings and roof repairs. The materials are categorized as Category II asbestos-containing material, in good condition, under the U.S. EPA NESHAP regulation.

Building 1002 Typical Condition (Lower Roof)

Building 1002- Asbestos containing roof penetration sealant is found on both levels of the roof system. Asbestos abatement is needed to remove the existing penetration sealants. This sealant can be found on all penetrations, including skylights.
